## TECHNICAL NOTE

TNOT-1423

## EDGE 2 V5.0.1

### AFFECTED PRODUCTS

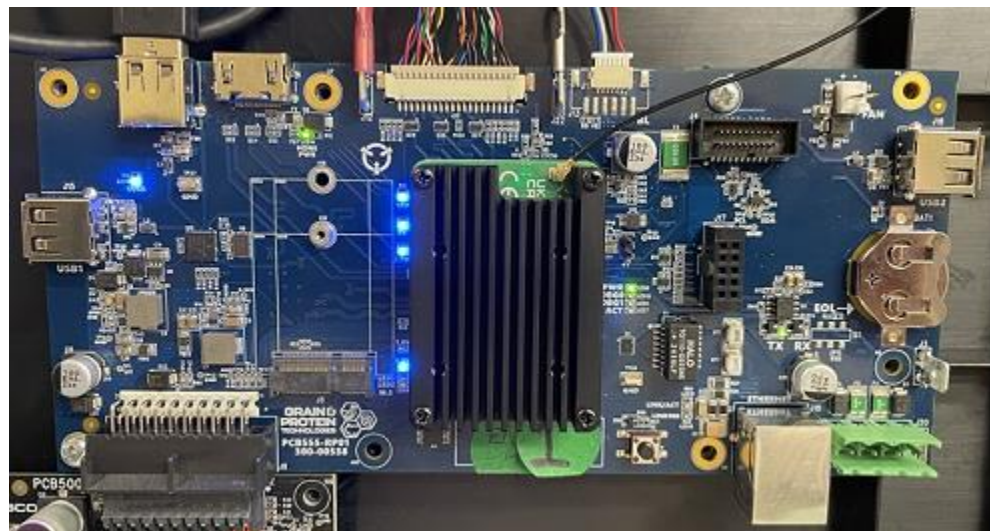
### New EDGE MPU Boards:

Version 5.0.1 can be installed on older MPU boards as well.
